ROCK SLOPE STABILIZATION

TSP 67-1
TACONIC STATE PARKWAY
(KITCHAWAN ROAD-BALDWIN ROAD)
WESTCHESTER COUNTY

SUBJECT TSP 67-1, TACONIC STATE PARKWAY, KITCHAWAN RD. TO BALDWIN RD.
WESTCHESTER COUNTY, PIN 8107.00-301, RECOMMENDATIONS FOR
REMEDIAL TREATMENT OF ROCK SLOPES

SUBJECT TSP 67-1
TACONIC STATE PARKWAY (KITCHAWAN RD. - BALDWIN RD.)
WESTCHESTER COUNTY, P.I.N. 8107.00-301

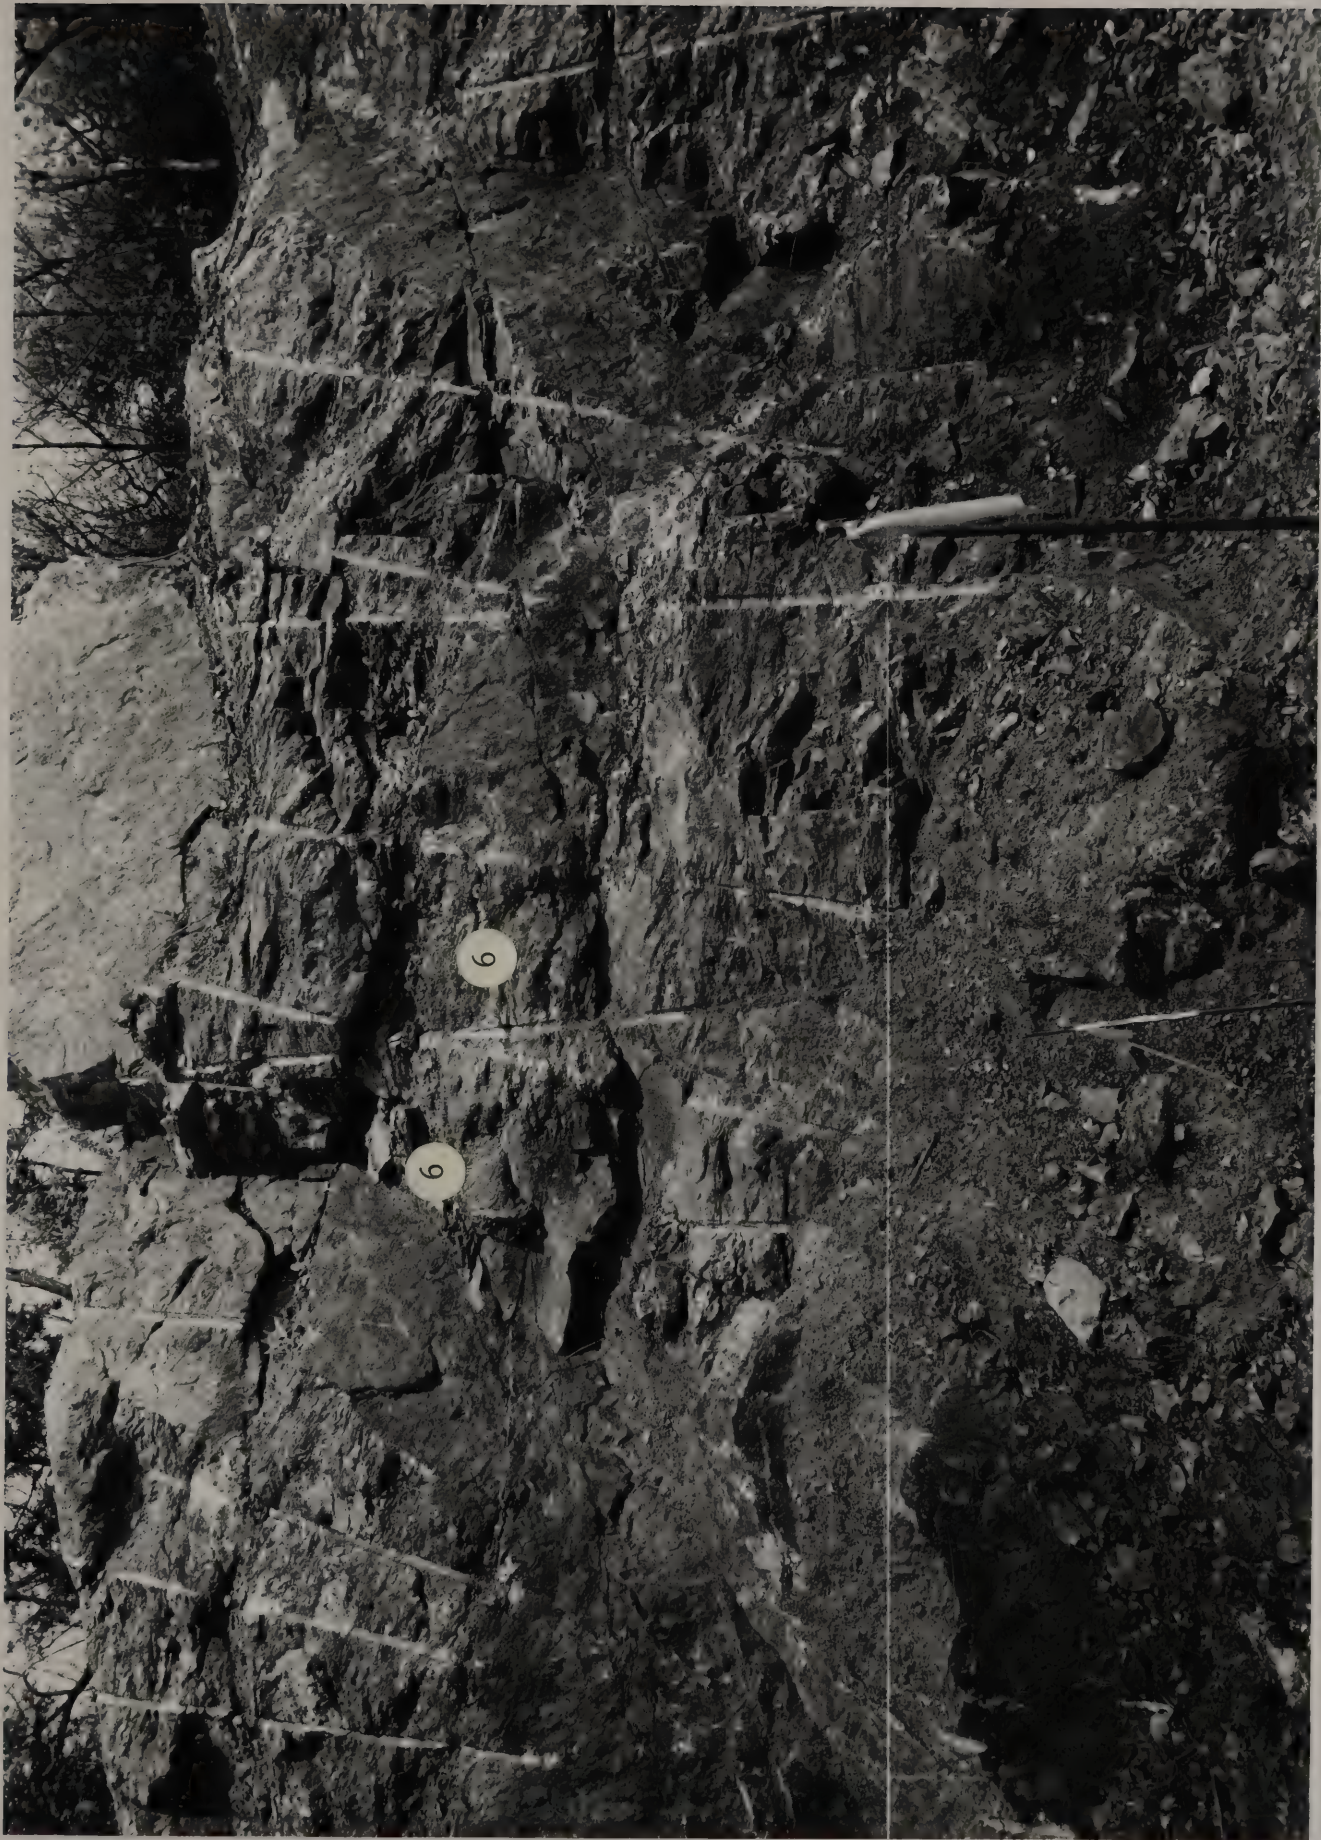
Figure No. 5 - "NE" Ramp Station 9+65 \pm , right.

It was concluded that 46 linear feet of rock bolts (6 bolts, six feet in length and 1 bolt, ten feet in length) would be required to stabilize the rock slopes examined on May 20, 1971. The locations of 4 of the bolts are illustrated in Figures No. 5 and 6.
